VKF 250,000 Gallon Elevated Water Storage Tank Inspection Report

Arnold Air Force Base / AEDC
Tullahoma, Tennessee

May 10, 2002

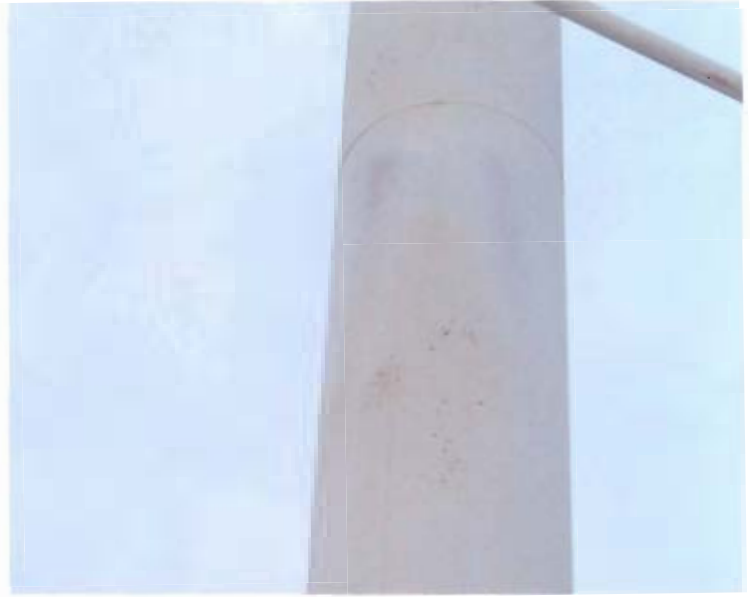
Top Right:

The protective coating in this area of the tank is in generally fair condition with scattered rust spots noted. There were several areas of spot coating failure that has allowed surface corrosion to develop.

Section of the support column showing corrosion and thin coating.

The exterior coating is nearing the end of it's useful service life. At present, the exterior coating is in fair to good condition with minor coating failure and corrosion scattered randomly over the tank. Due to poor adhesion of the coatings, the tank will require complete removal of the old paint prior to re-painting.

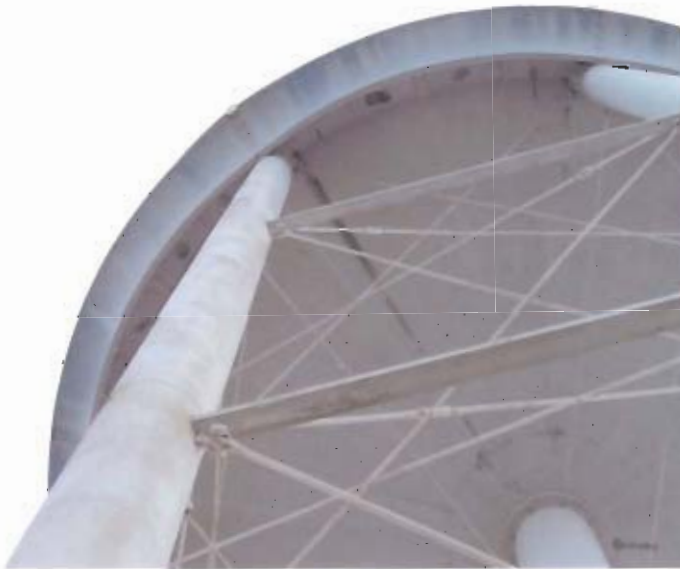
Bottom Left:

Structure and bowl of the tank shows thin coating and mildew.

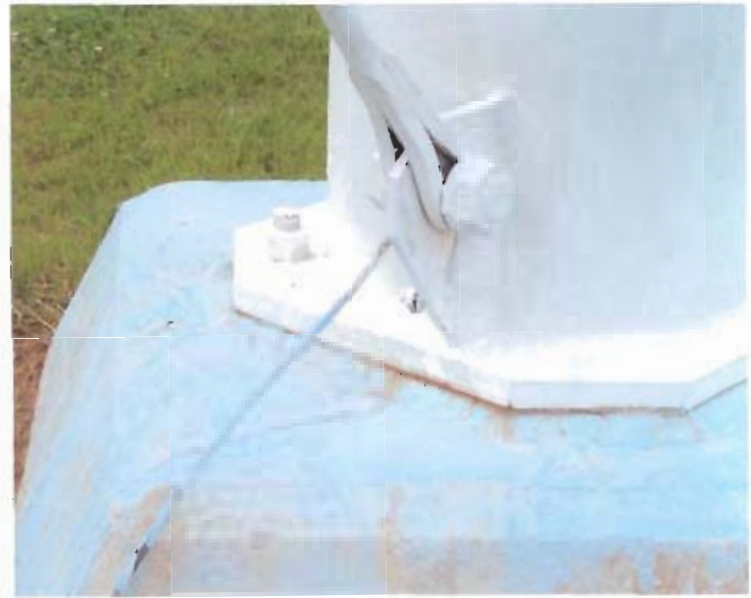
Bottom Right:

Concrete piers are all in good condition. Tank is properly grounded.

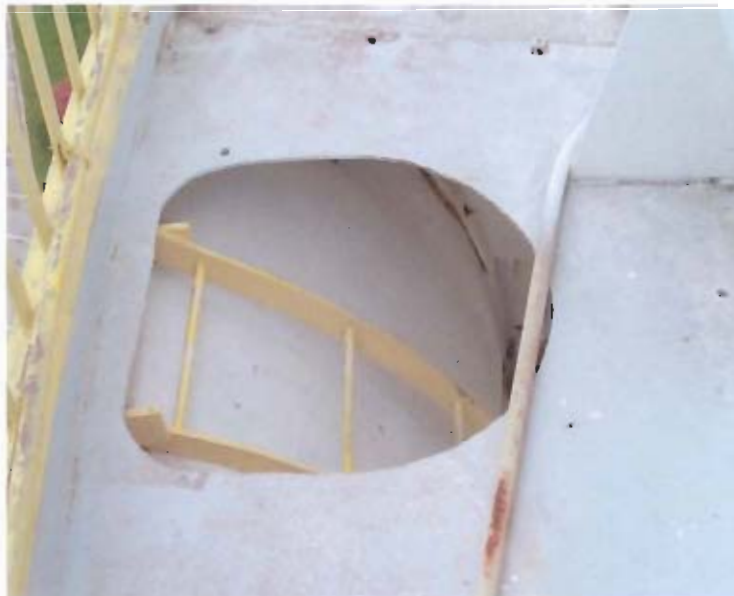
Top Right:

Entry of the ladder to the balcony floor is of poor design. The passage is narrow and restrictive, making it hazardous to workers climbing the structure. The balcony floor has an opening 20" x 22" for access to the balcony area. Safety chains should be installed on both sides of this opening for workers safety.

Access ladder from structure to the balcony floor. This opening should be protected by safety chains.

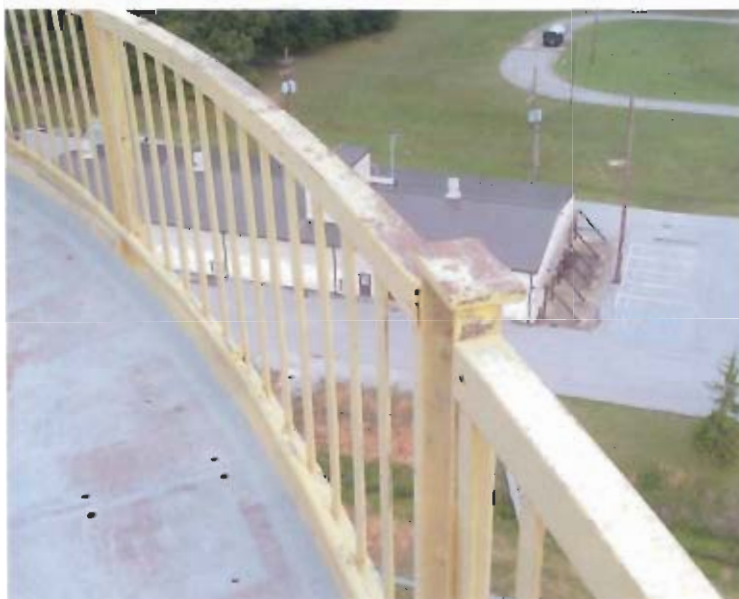
Bottom Left:

The protective coating in this area of the tank is in fair condition, but is nearing the end of its useful service life. Random coating failure has allowed surface corrosion to develop on the support structure, balcony and railing. The balcony floor has several areas that hold water. The standing water has allowed corrosion and premature coating failure to occur.

Balcony floor and railing showing thin, worn coating.

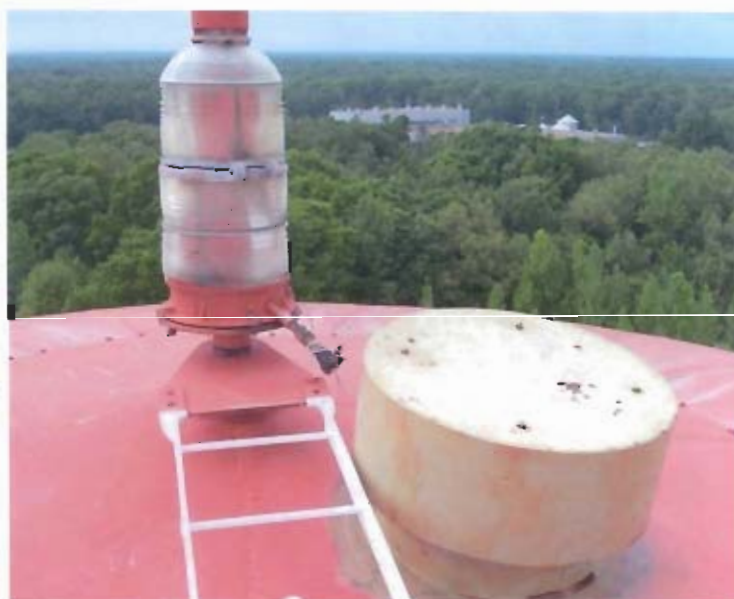
Bottom Right:

The protective coating in this area of the tank was in fair to good condition. The coating is wearing thin with age and shows sign of failure with spot rust and delamination of the top coat from the primer. The red colored dome is faded and chalky to the touch.

Central vent is rusting, aircraft warning light is disconnected. The coating is faded and chalked from exposure and age.

Aircraft warning lights on the tank do not work. If needed, the lights should be restored to proper operation.

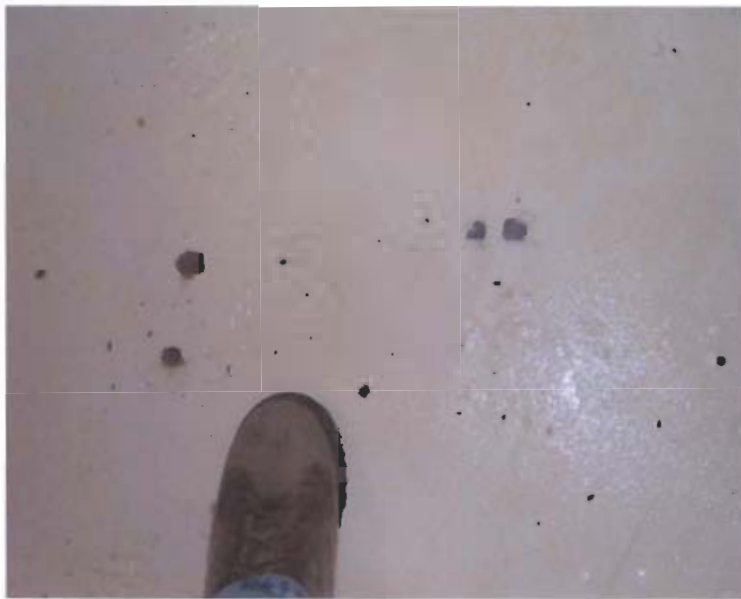
Prior to the clean-out, the bowl of the tank was covered with a buildup of sediment and silt approximately 1" deep. The epoxy paint appears to be in fair condition with some scattered pitting, rust tubercles and active electrolysis noted. Random weld seam rust is visible in the bowl and riser. The deepest pits are approximately 1/8 inch in depth.

- Top Left:** Pitting from active electrolysis on the tank bowl.
- Top Right:** Rust and pitting in floor plates and weld seams.
- Bottom Left:** View of the riser from the tank bowl.
- Bottom Right:** Cathodic protection cables found on tank floor.

The interior coating is doing a poor job of protecting the steel. The complete removal and replacement of the interior coating should be completed the near future, as the existing lining will become ineffective and corrosion will accelerate as more substrate is exposed. Some pitting and electrolysis is now occurring with steel loss notable.

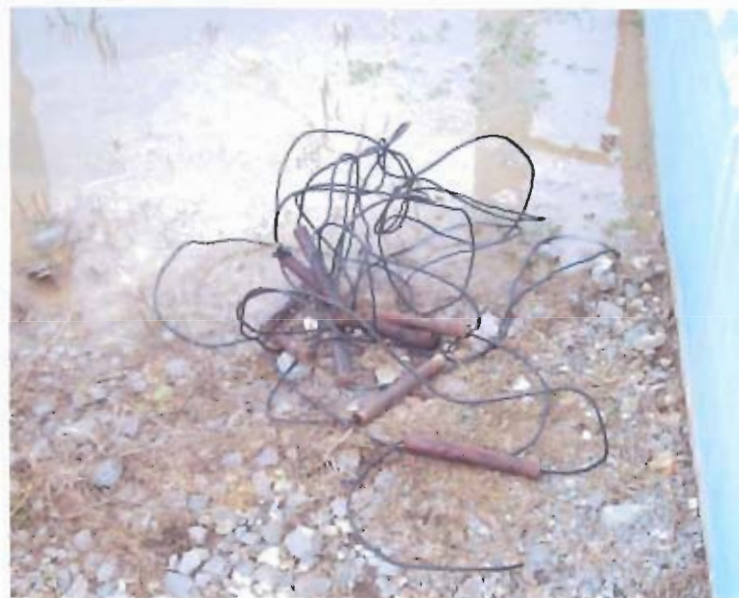
Several sections of the cathodic protection system had fallen to the floor of the tank and were removed by our service crew during the cleaning and inspection.

The cathodic protection system should be properly maintained and regulated if left in the tank.

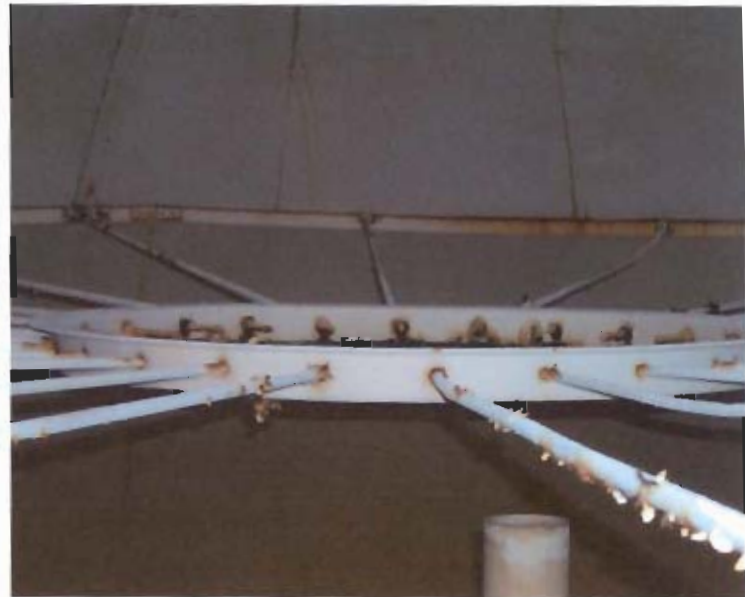
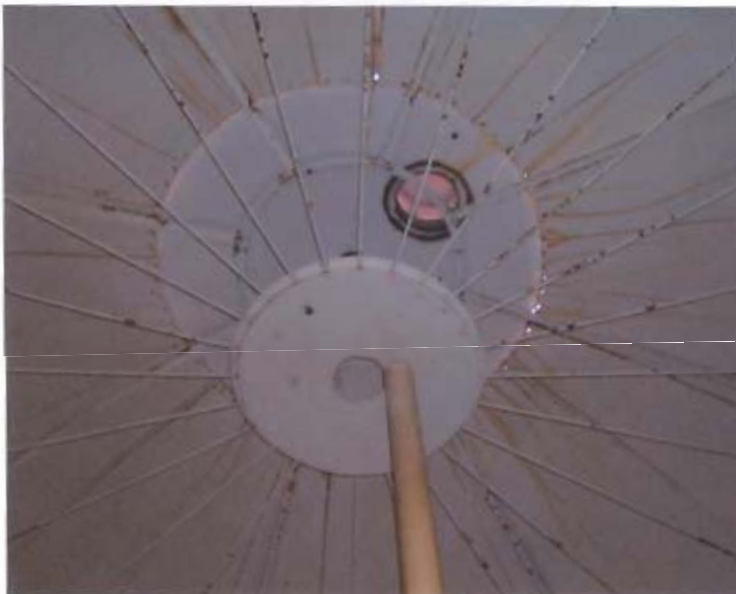
The tank still has a spider assembly in place. The spider is rusting, but is still structurally sound.

- Top Left:** Interior bowl at the riser showing riser safety grate in place. This photo was made prior to cleaning the sediment out.
- Top Right:** Eye level view of the spider assembly shows rusting.
- Bottom Left:** View of the spider assembly from the floor of the tank.
- Bottom Right:** Worker cleaning silt and sediment from the tank prior to the Inspection.
